NEW ANTI-FOULANT CLAR10670A IMPROVES PRODUCED WATER COOLER FOULING PERFORMANCE OVER PREVIOUS GENERATION

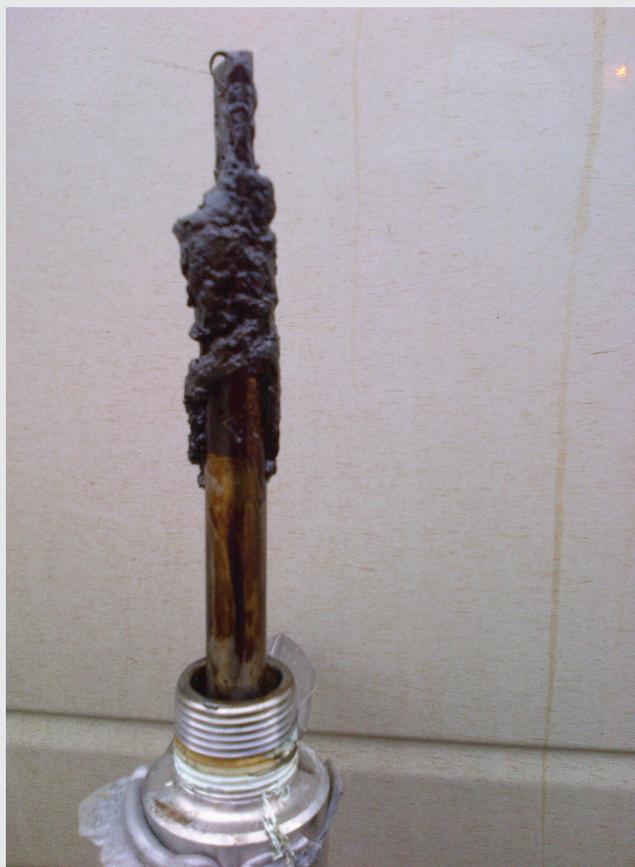
Sample of the organic deposits formed on a scale coupon installed at the heat exchanger.

Thermal heavy oil produced fluids often reach temperatures in excess of 160°C (320°F). At these high temperatures, many organic compounds become soluble in the produced water. When produced water is separated from the produced emulsion in separation vessels, these water-soluble organics exit the vessel with the produced water. Produced water is then passed through shell-and-tube heat exchangers, cooling the water from 125°C (257°F) to 90°C (194°F) by exchange with colder boiler feed water. At these lower temperatures, the water-soluble organics are less soluble and begin to precipitate onto the inside of the exchanger tubes.

Further challenges are caused by solids, such as sand and inorganic scales, that can become stuck to the organic deposits. These deposits can plug tubes leading to impinged water flow and hot spots, reducing the efficiency of the exchangers, and potentially causing mechanical failure. To prevent these failures and reduce the frequency of costly cleanouts, Nalco Champion injected a first-generation dispersant to prevent the organics from depositing in the tubes. This dispersant required high rates of injection, however, and the customer sought a more cost-effective solution.
